Doc. No.: HS-232ENG	<h1>IRATA</h1> <h2>Safety Bulletin No. 45</h2>

SAFETY BULLETIN NO. 45: FALL FROM HEIGHT: AID CLIMBING

A safety bulletin aimed at raising awareness of hazards in the rope access industry. The text may be of use as part of a toolbox talk.

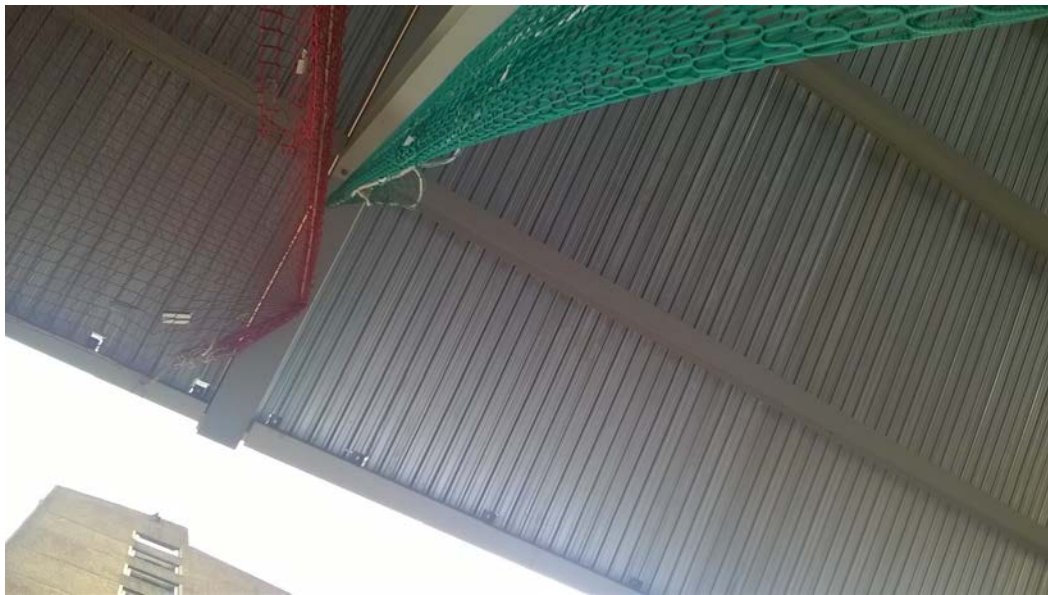
Photo 1:

- 3.2.5 **First accident:** When the end of a beam was reached it was necessary for the technician to reposition themselves on the other side of the steelwork connection, so that de-rigging could continue. In order to do this, and to attach their third beam glider to the bottom flange in the adjacent span, he needed to lean across and release the first safety net anchor. This involved grabbing the rigged safety net - which had some tension in it - and pulling it towards him.

First accident: Look upwards at the area to be de-rigged (left) and the area that had just been de-rigged.

The width of the bottom flange reduces from 200mm wide (right) to 150mm wide (left). The depths of the beams were also different.

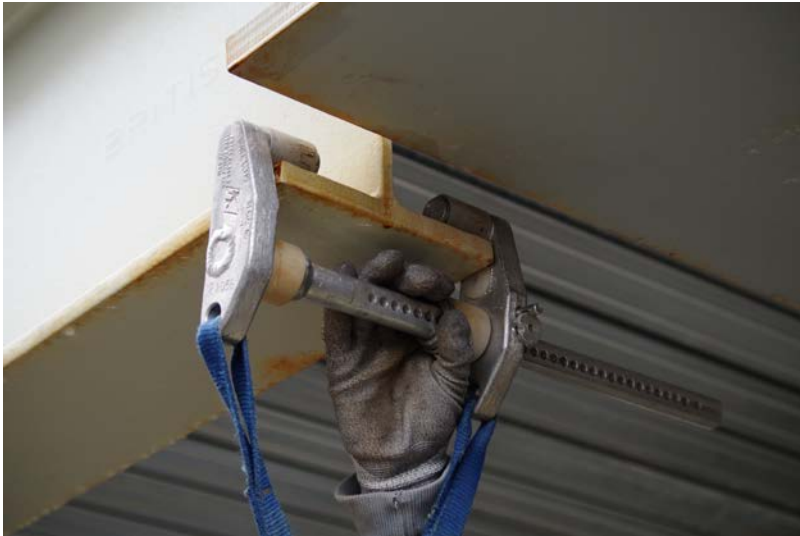
Photo 2:

- 3.2.6 There was a gap between the bottom flange of the beam and the flange of its connecting column. This dimension was such that it did not prevent the wheels on the beam glider passing through it. Thus, this resulted in the technician falling from height when losing both his primary support and back-up when the beam gliders were pulled off and/or fell off the open end of the bottom flange (see **Photo 2**).

First accident: Beam glider at open end of beam (37mm wide gap) [Reconstruction]

3.2.7 It appears that the equal and opposite horizontal reaction had not been recognised; and the direction of loading was no longer purely vertical.

- (a) ‘open ended’ bottom flange detail due to specification of differing member sizes;
- (b) the potential for an equal and opposite horizontal reaction had not been recognised;
- (c) in the second case, the work was taking place in an area away from that planned as the original area was not available.

- (a) designing the steelwork in such a way as to eliminate or substantially reduce open ends or cut outs; or if these are necessary;
- (b) introducing cleats or 'man locks', for example, that would prevent a beam glider leaving the steelwork (see 3.4);
- (c) considering the use of locking beam gliders which can be clamped to prevent unplanned movement;
- (d) ensuring a thorough pre-start check is carried out to identify any open-ended steelwork from the ground before gaining access at height.

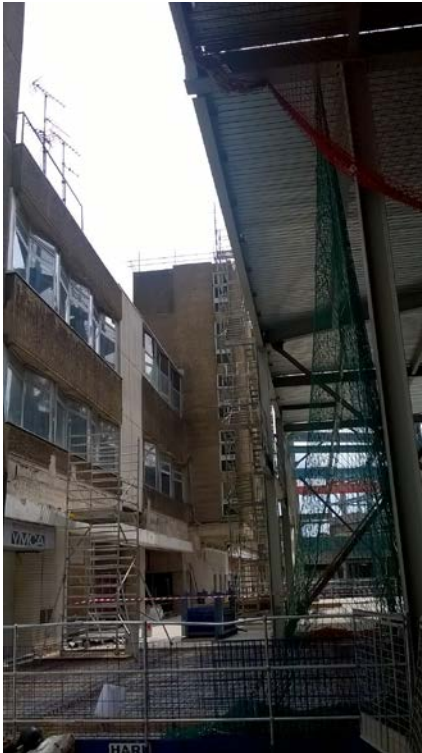
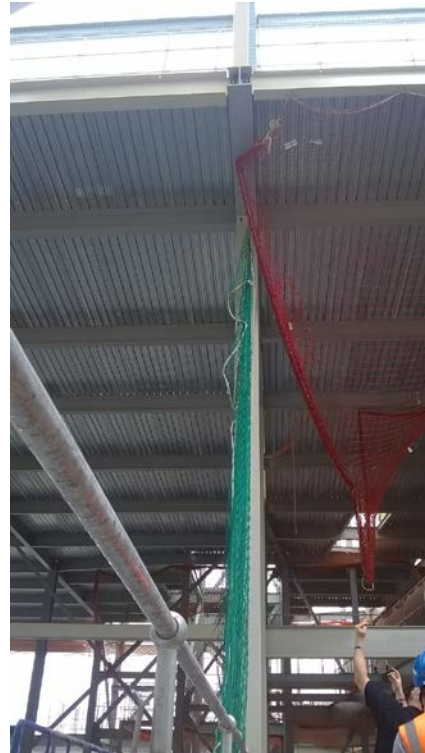
Photo 3:

3.2.8 **Second accident:** The technician, using three beam gliders, was travelling along the steel beam and did not identify an open-ended bottom flange, where two beams met. He pulled himself past this gap, which resulted in the primary and back-up support being lost and a fall occurring.

The location of the fall in one of the incidents
